PRELIMINARY ASSESSMENT FOR  
ROBERT WOOLER COMPANY SITE  
Dresher, Montgomery County, Pennsylvania  
Dump Site No. PA-2700  
EPA ID No. PAD987279387

February 1993

HAZARDOUS WASTE MANAGEMENT DIVISION  
U.S. Environmental Protection Agency

ECOLOGY AND ENVIRONMENT, INC.  
Philadelphia, Pennsylvania

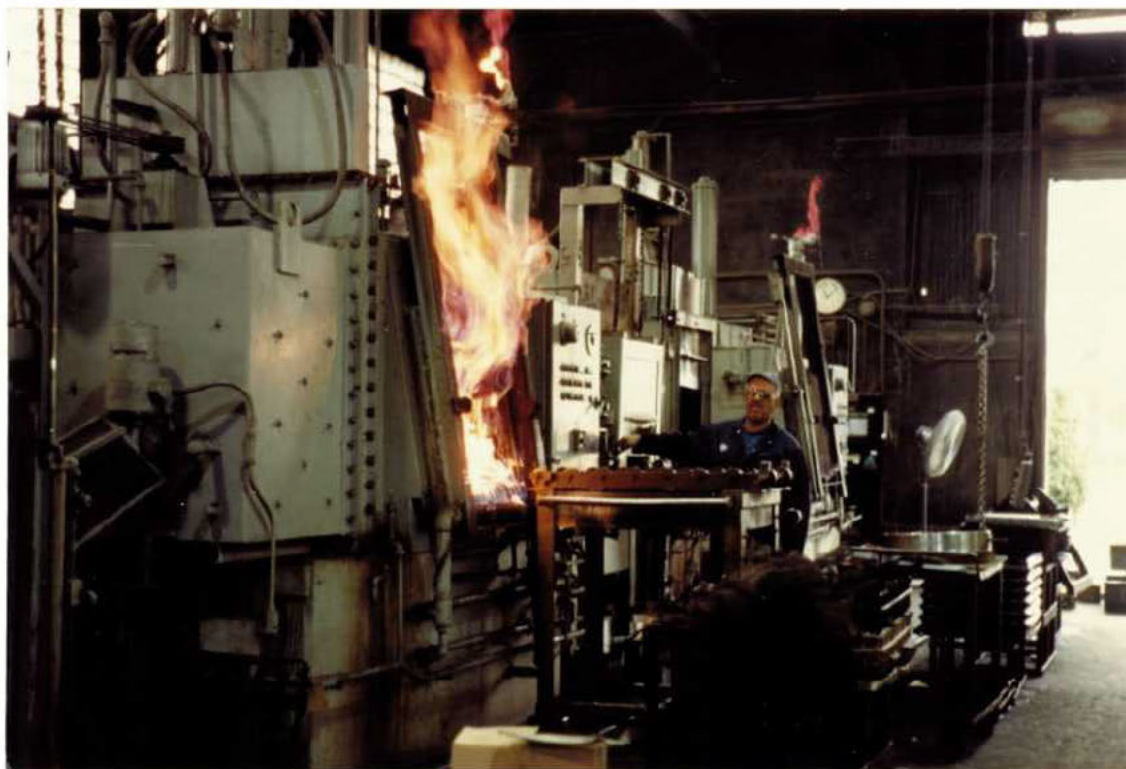
Client: USEPA Region III	E & E Job No.: ZE5580
Site: Robert Wooley Company	
Camera: Make Pentax	SN 4759340 (EPA Decal 897603)
Lens Type 50 mm	SN 3687638
	Photographer: [REDACTED] Date: 11/05/92
	Time: 11:10 Frame No.: 1
	Comments*: View of AF-3 and AF-5 furnace lines inside plant No. 1.
*Comments to include location.

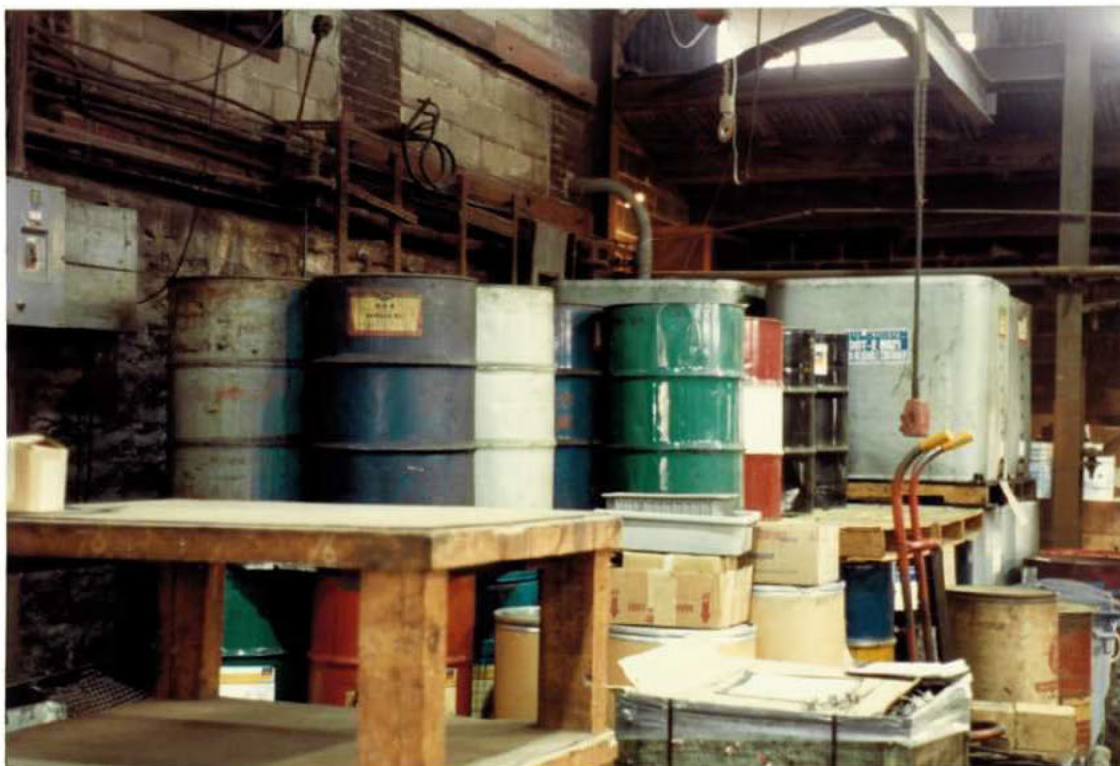
Client: USEPA Region III	E & E Job No.: ZE5580
Site: Robert Wooller Company	
Camera: Make      Pentax	SN      4759340 (EPA Decal 897603)
Lens Type      50 mm	SN      3687638
	Photographer: [REDACTED]      Date: 11/05/92
	Time: 11:15      Frame No.: 3
	Comments*: View of empty container storage area
	inside plant No. 1.
*Comments to include location.

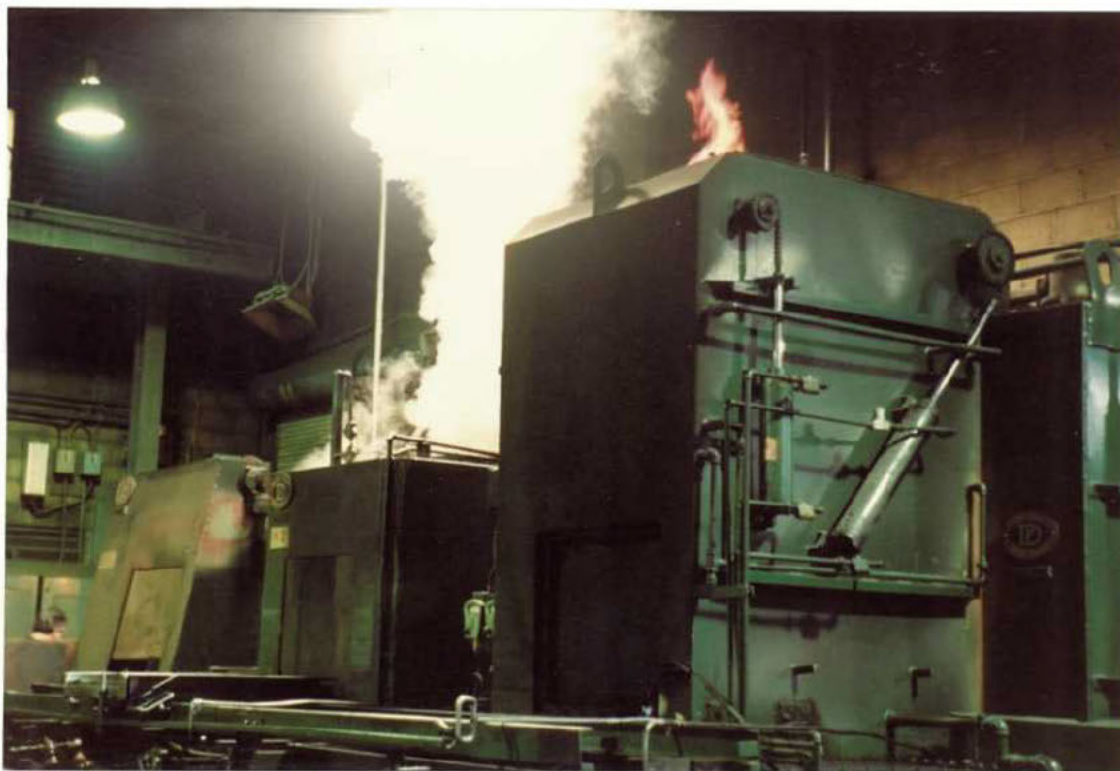
Client: USEPA Region III	E & E Job No.: ZE5580
Site: Robert Wooller Company	
Camera: Make      Pentax	SN      4759340 (EPA Decal 897603)
Lens Type      50 mm	SN      3687638
	Photographer: <span style="background-color: black; color: red;">Not Responsive Based on Revised Scope</span> Date: 11/05/92
	Time: 11:20      Frame No.: 6
	Comments*: View of AF-4 furnace line inside plant
	No. 2
*Comments to include location.

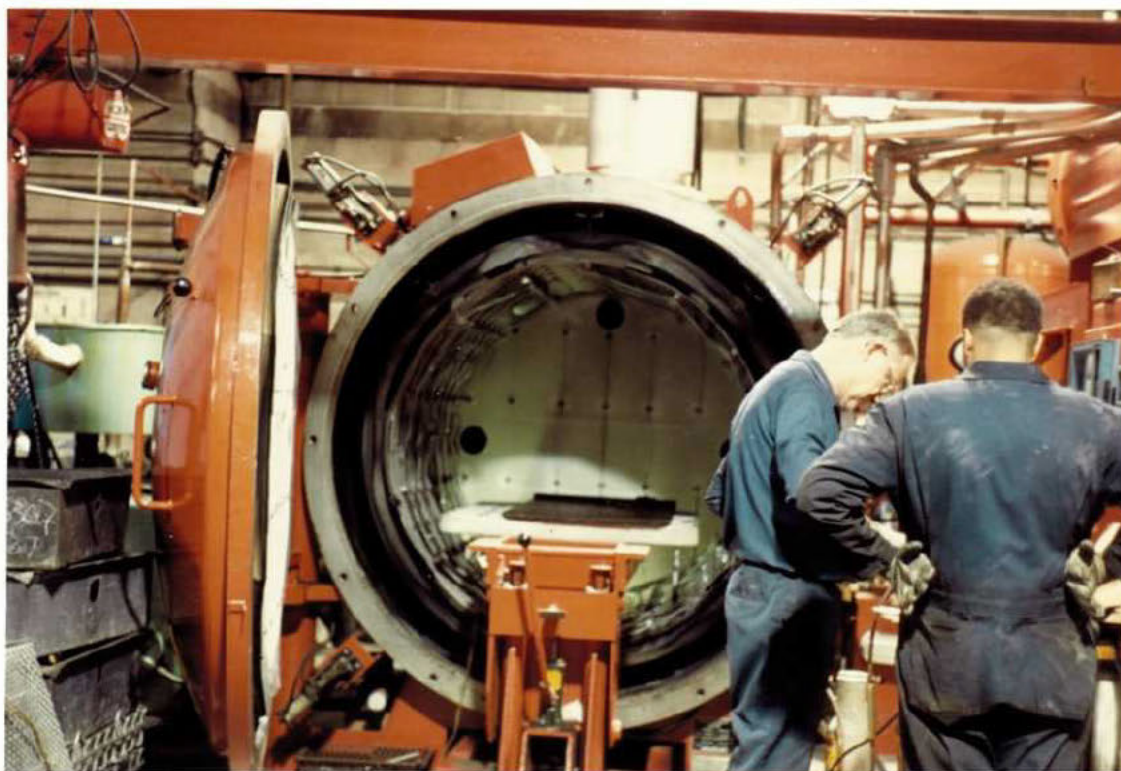
Client: USEPA Region III	E & E Job No.: ZE5580
Site: Robert Wooller Company	
Camera: Make      Pentax	SN      4759340 (EPA Decal 897603)
Lens Type      50 mm	SN      3687638
	Photographer: <span style="background-color: black; color: red;">Not Responsive Based on Revised SP</span> Date: 11/05/92
	Time: 11:25      Frame No.: 10
	Comments*: View of vacuum unit located inside
	facility.
*Comments to include location.

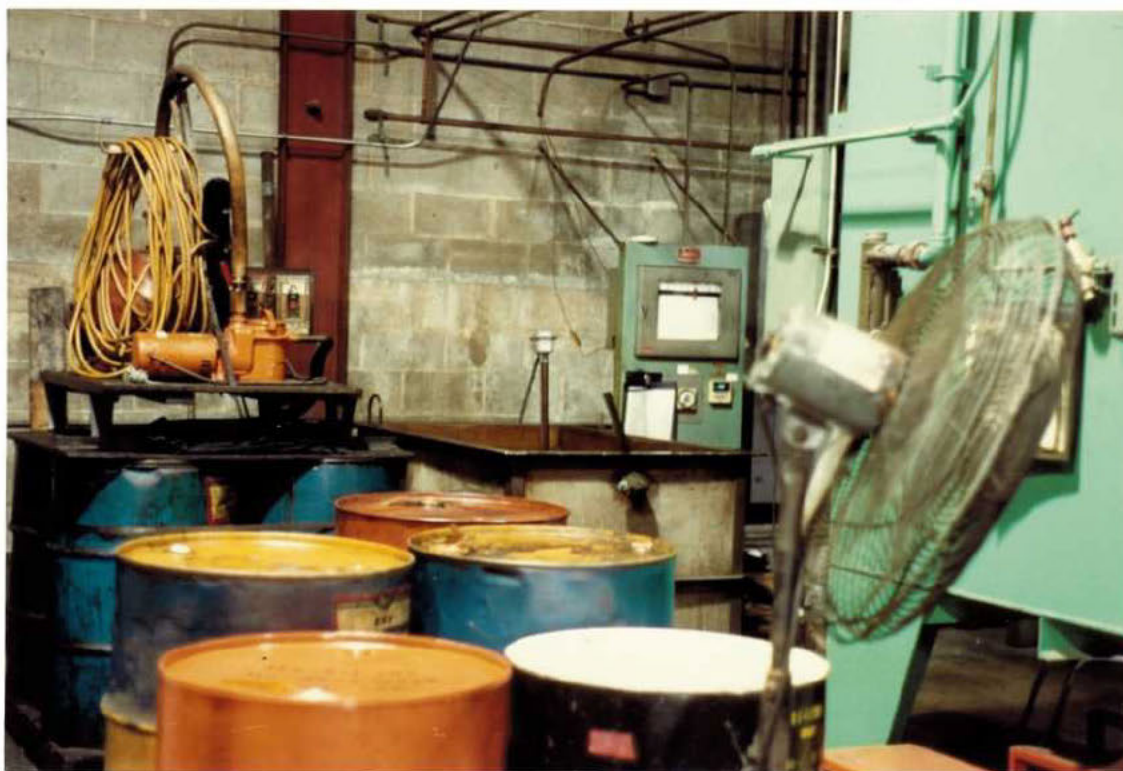
Client: USEPA Region III	E & E Job No.: ZE5580
Site: Robert Wooller Company	
Camera: Make Pentax	SN 4759340 (EPA Decal 897603)
Lens Type 50 mm	SN 3687638
	Photographer: <span style="background-color: black; color: red;">Not Responsive Based on Revised SA</span> Date: 11/05/92
	Time: 11:30 Frame No.: 12
	Comments*: View of mineral oil recycling area located inside building.
*Comments to include location.

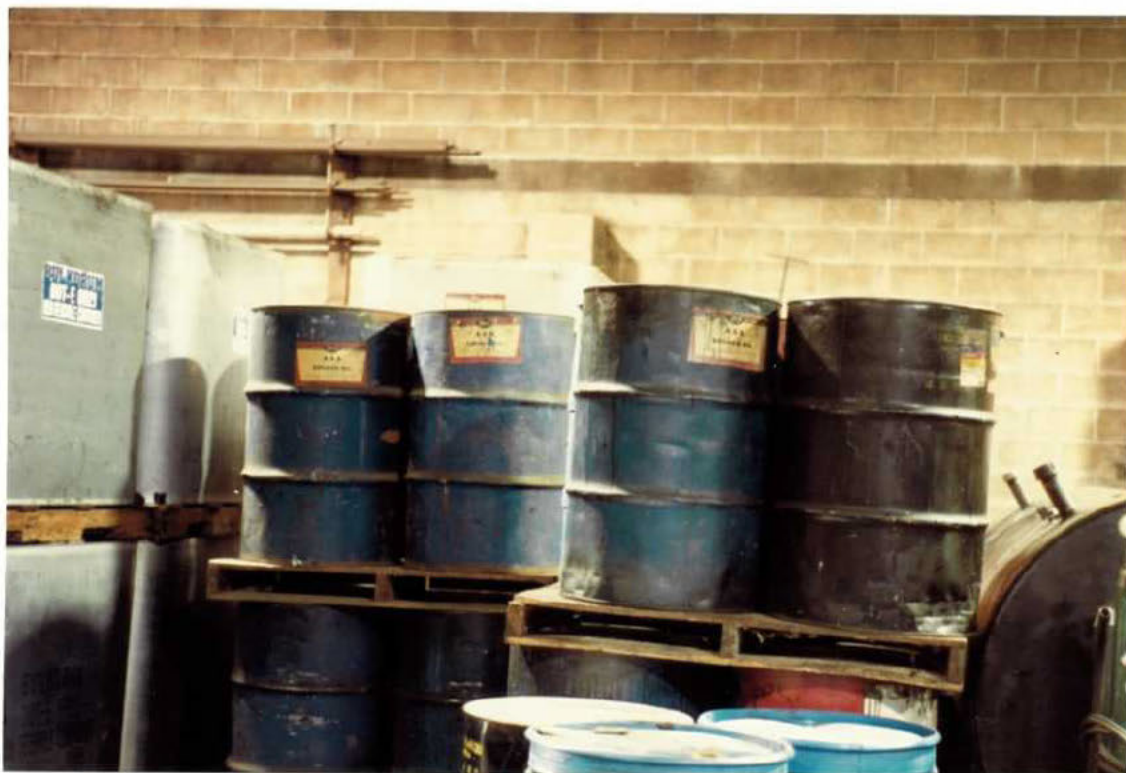
Client: USEPA Region III	E & E Job No.: ZE5580
Site: Robert Wooller Company	
Camera: Make      Pentax	SN      4759340 (EPA Decal 897603)
Lens Type      50 mm	SN      3687638
	Photographer: <span style="background-color: black; color: red;">Not Responsive Based on Revised Gorp</span> Date: 11/05/92
	Time: 11:30      Frame No.: 14
	Comments*: View of material storage area (mineral oil for quenching) located inside facility.
*Comments to include location.

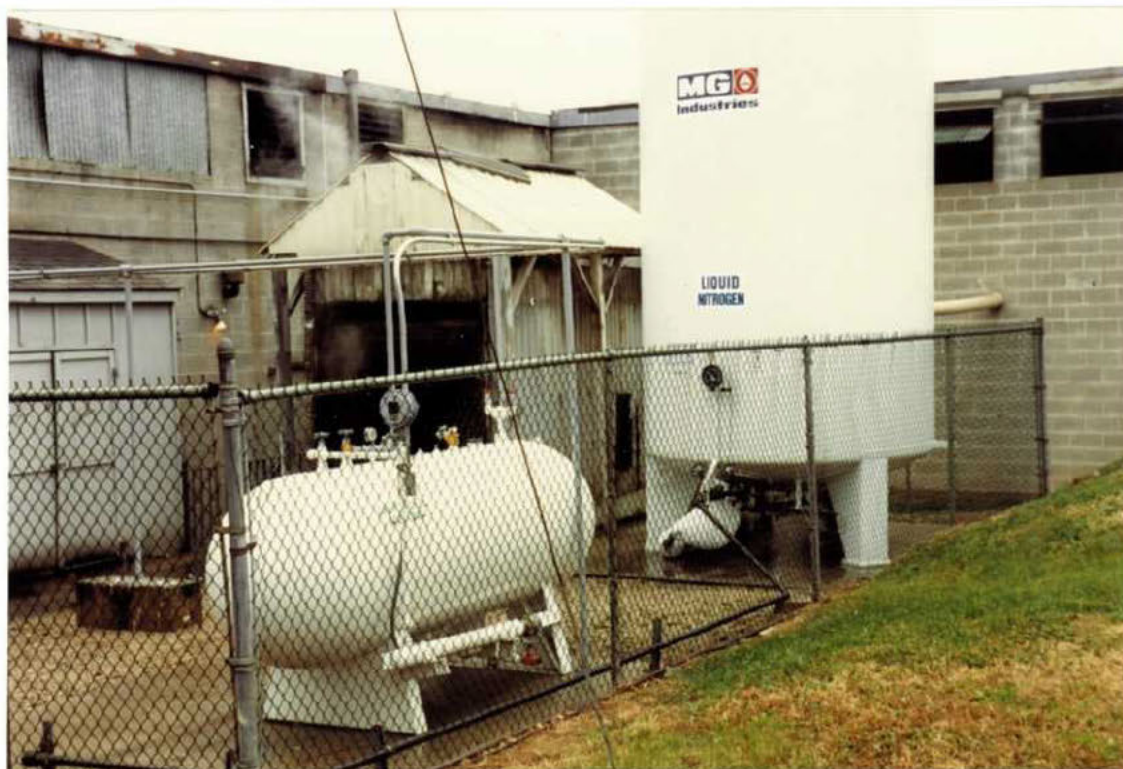
Client: USEPA Region III	E & E Job No.: ZE5580
Site: Robert Wooller Company	
Camera: Make      Pentax	SN      4759340 (EPA Decal 897603)
Lens Type      50 mm	SN      3687638
	Photographer: <span style="background-color: black; color: red;">Not Responsive Based on Revised Site</span> Date: 11/05/92
	Time: 11:45      Frame No.: 17
	Comments*: View of anhydrous ammonia and liquid nitrogen tanks, with Niagara cascade unit in background. Tanks are located on the south corner of the building.
*Comments to include location.

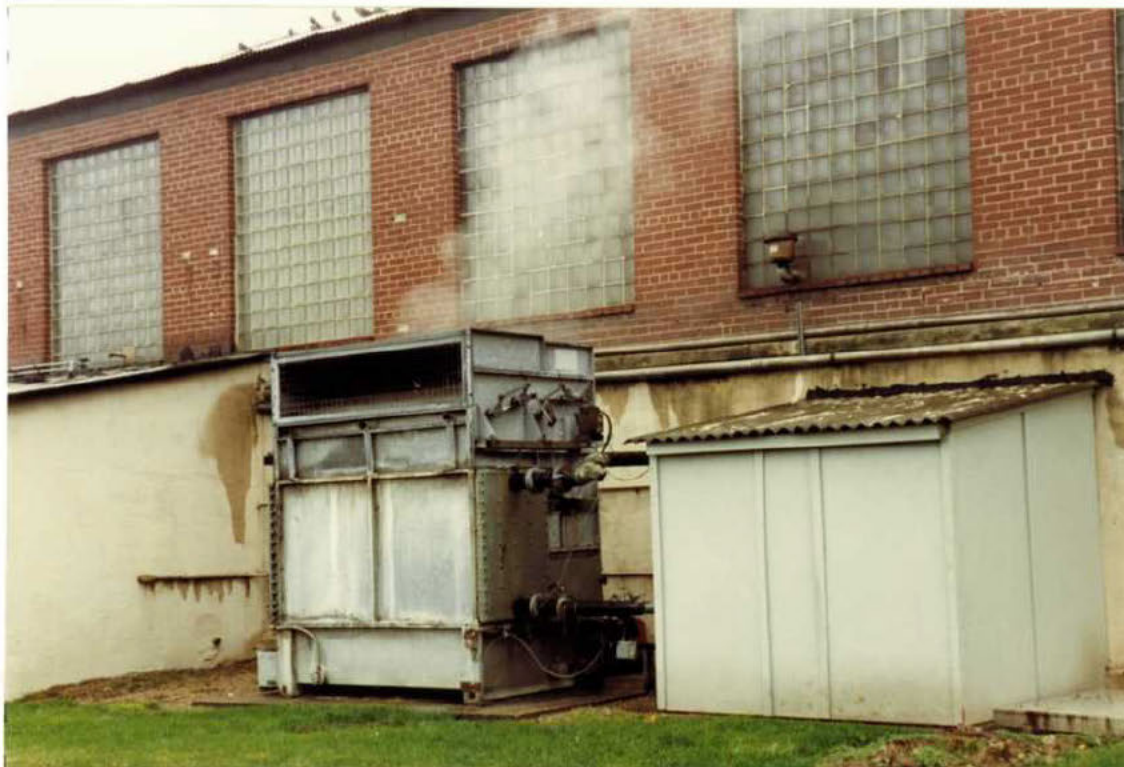
Client: USEPA Region III	E & E Job No.: ZE5580
Site: Robert Wooler Company	
Camera: Make      Pentax	SN      4759340 (EPA Decal 897603)
Lens Type      50 mm	SN      3687638
	Photographer: <span style="background-color: black; color: red;">Not Responsive Based on Revised Scope</span> Date: 11/05/92
	Time: 11:50      Frame No.: 18
	Comments*: View of Niagara cascade unit and
	reservoir shed located on northwest wall of facility.
*Comments to include location.

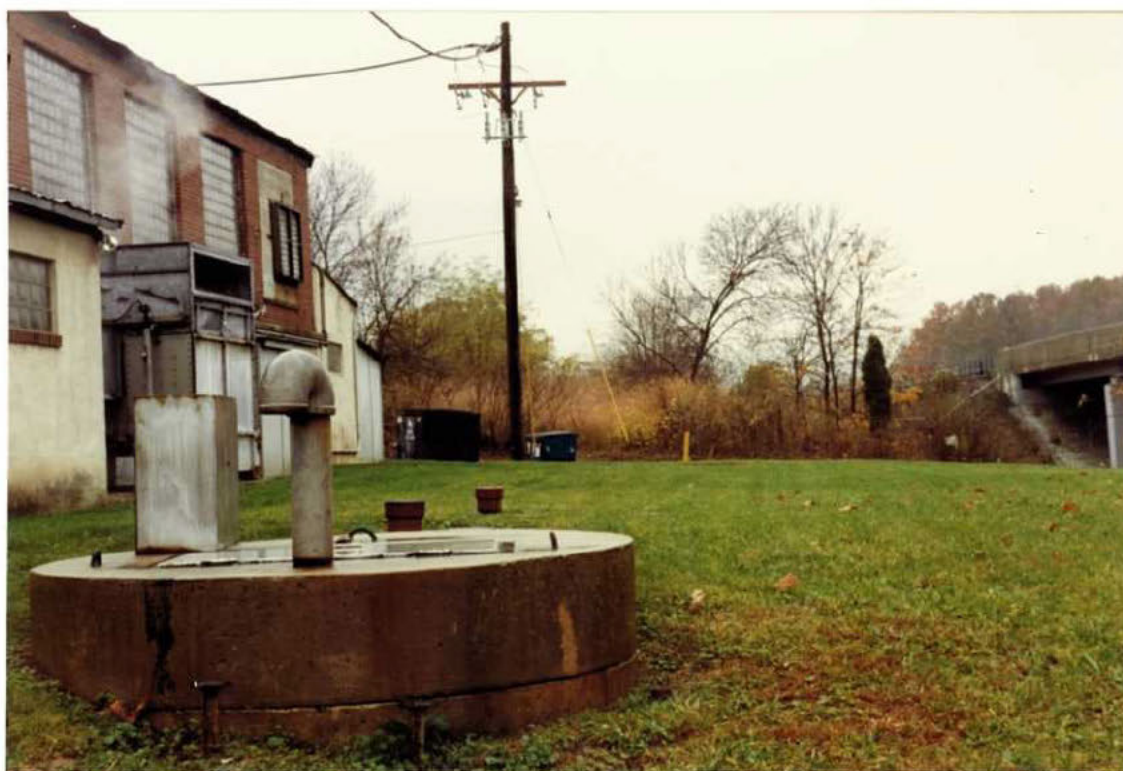
RWC maintained an on-site septic field until it was connected to the municipal sewer system in the early 1980s. The septic system was backfilled when the site was connected to the municipal system. Until February 1992, algaecide was discharged to the storm sewer that discharged to an unnamed tributary of Sandy Run Creek; Sandy Creek is located approximately 1,000 feet north of the site (Refs. 2, 3). RWC received a Notice of Violation (NOV) concerning the algaecide and ceased discharge to the storm sewers. Currently, the sanitary sewer connection receives a weekly discharge of backflushed green algaecide from the

Client: USEPA Region III	E & E Job No.: ZE5580
Site: Robert Wooller Company	
Camera: Make      Pentax	SN      4759340 (EPA Decal 897603)
Lens Type      50 mm	SN      3687638
	Photographer: <span style="background-color: black; color: red;">Not Responsive Based on Revised Scope</span> Date: 11/05/92
	Time: 11:50      Frame No.: 19
	Comments*: View along northwest wall of building
	showing connection to sewer, Niagara cascade, reservoir
	shed, and former septic field.
*Comments to include location.

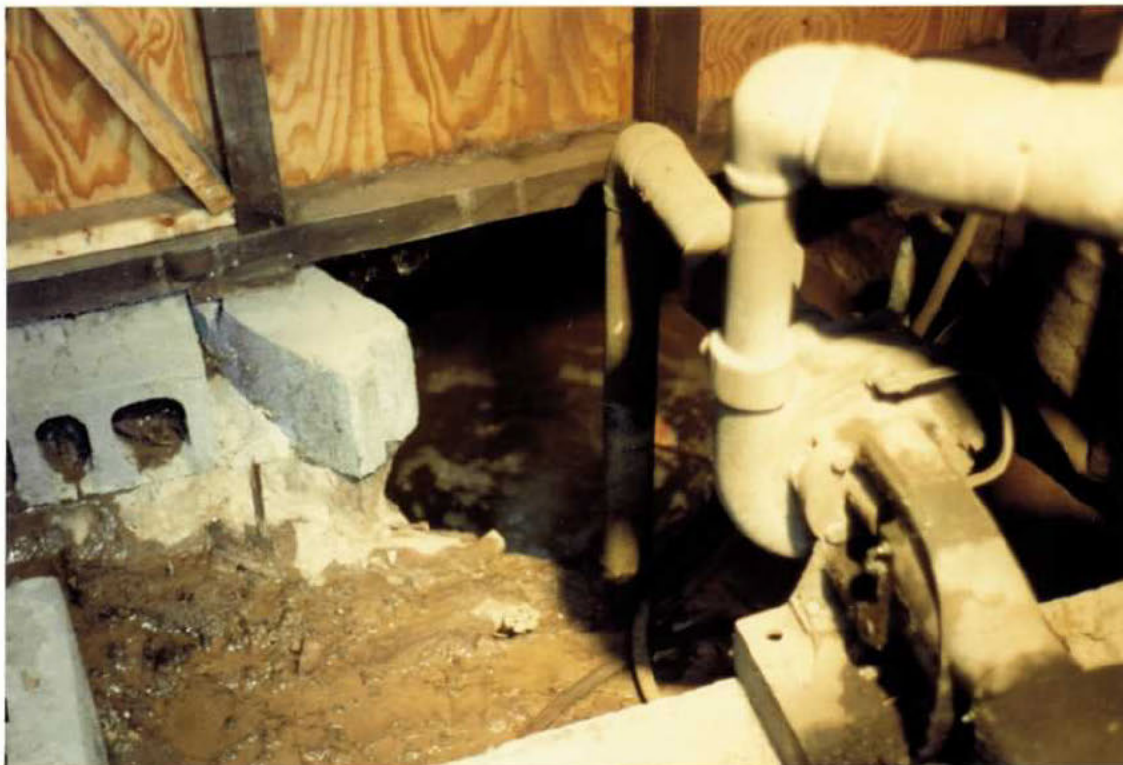
Client: USEPA Region III	E & E Job No.: ZE5580
Site: Robert Wooller Company	
Camera: Make Pentax	SN 4759340 (EPA Decal 897603)
Lens Type 50 mm	SN 3687638
	Photographer: <span style="background-color: black; color: red;">Not Responsive Based on Revised Scope</span> Date: 11/05/92
	Time: 11:55 Frame No.: 20
	Comments*: View of reservoir for process water
	located inside a shed on the northwest side of building.
*Comments to include location.

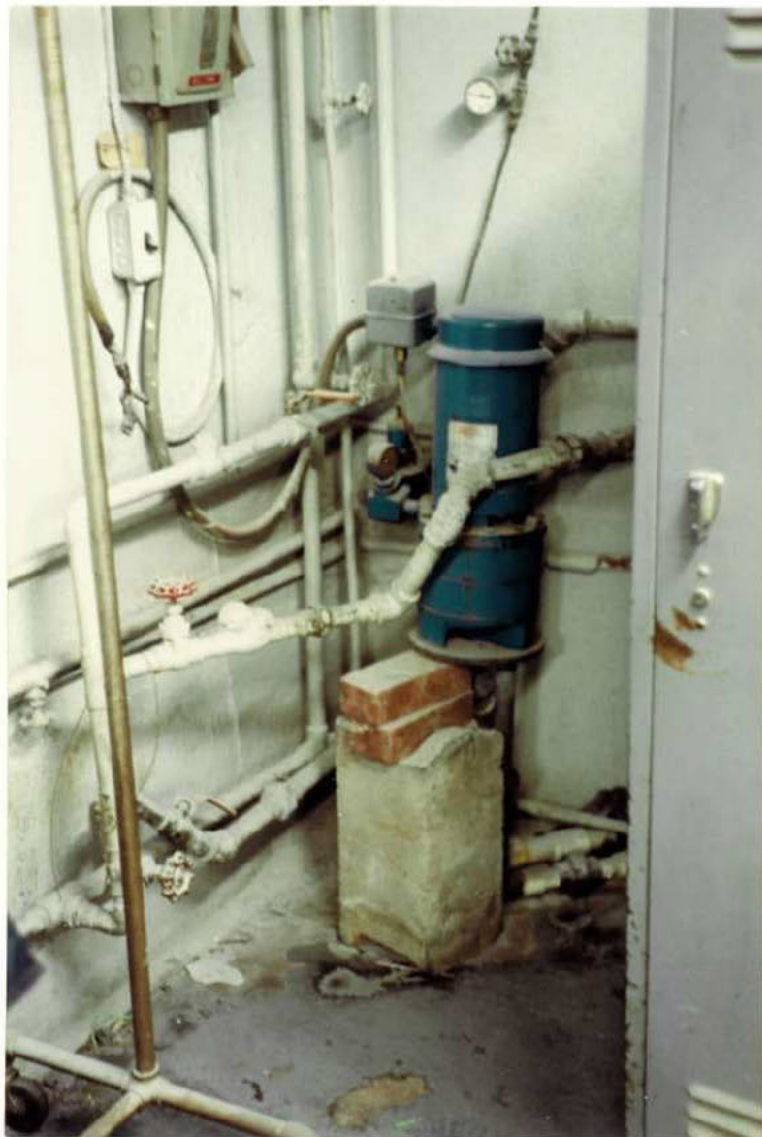
The RWC well was sampled in 1989 as part of a nearby site investigation. It was found to be contaminated with 270 parts per billion (ppb) TCE, 22 ppb tetrachloroethene, 52 ppb 1,1,1-TCA, and 52 ppb 1,1-dichloroethene (See Appendix C). RWC utilized two TCE degreasing units from 1963 to 1985 which were maintained by Gold Shield, Inc. A Gold Shield manifest indicated that approximately 200 gallons of spent solvent (TCE) was removed per month and replaced with clean solvent. It is unclear, but unlikely, whether this volume remained constant throughout the period that degreasers were on site. No spills or releases of TCE are reported by RWC officials (Refs. 1, 3, 17).

Comments\*: View of Robert Wooler Co. non-contact  
process water supply well inside employee locker room.
